TRUCK ROUTE ACCESS EVALUATION

Hopkinsville Industrial Park
Off US 41 South of Hopkinsville
Site #41

Report No. KTC-98-26

"Freight Movement and Intermodal Access in Kentucky"
Project No. SPR 98-189

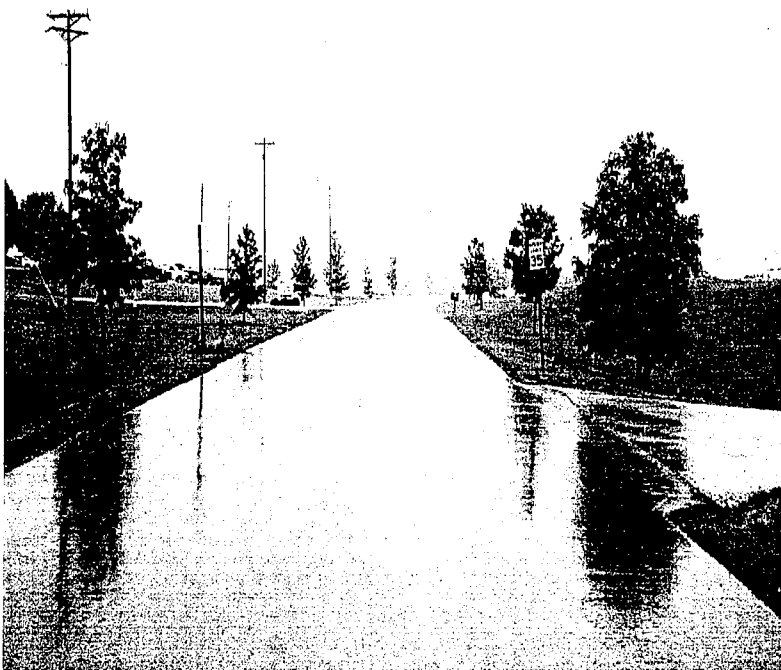
Figure 3: Bill Bryan Boulevard

road just south of the industrial park. Trucks in the industrial park travel on a two lane roadway within the park to access US 41. A portion of this road is divided. Bill Bryan Boulevard is about one mile in length with about one third of the road divided (Figure 3). Commerce Drive is about 0.8 mile in length and is a two lane road. The general character of the area is urban. Right of way at the driveways from the industrial park to US 41 is controlled by a stop sign on the driveways. Right of way at the Pennyrile Parkway is controlled by stop signs on the exit ramps.
